INJE UNIVERSITY SANGGYE PAIK HOSPITAL

# A case of deep neck infection after re-cementation of implant crown

<sup>1</sup> Department of OMFS, Sanggye Paik Hosp., College of Medicine, Inje University

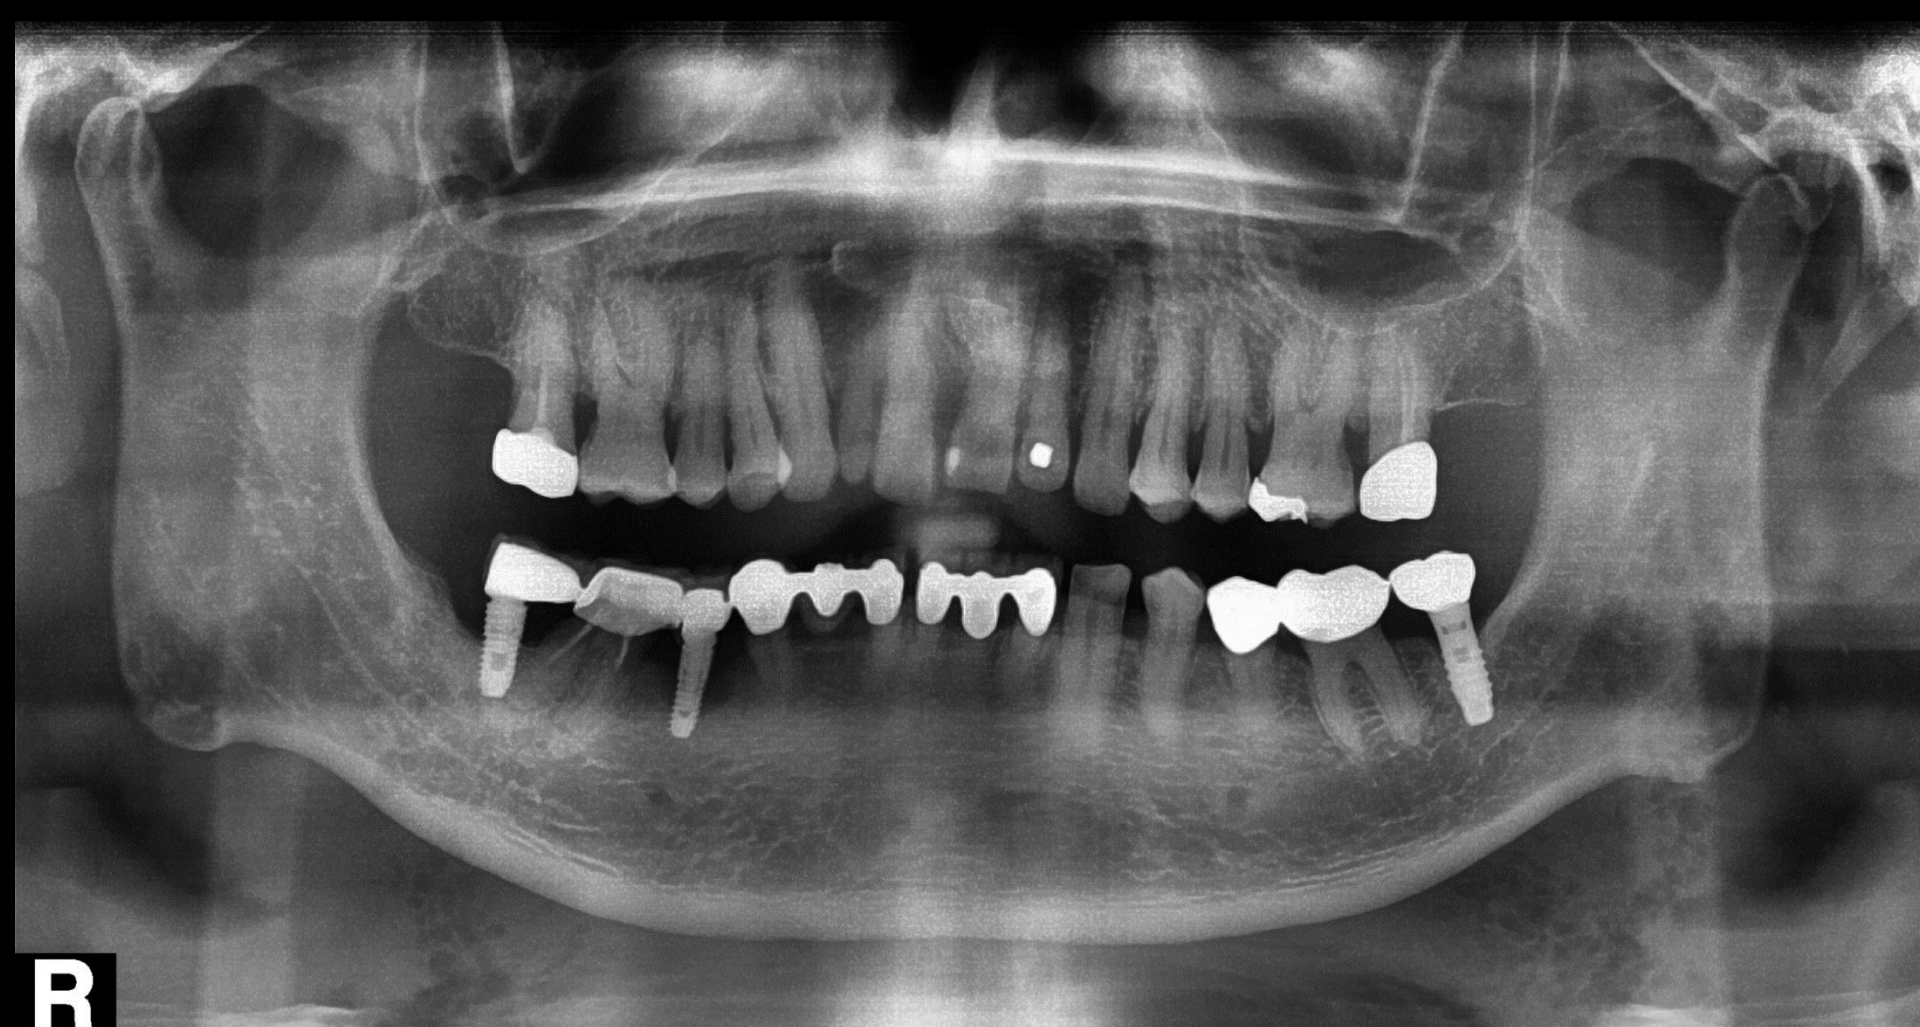
First visit panorama

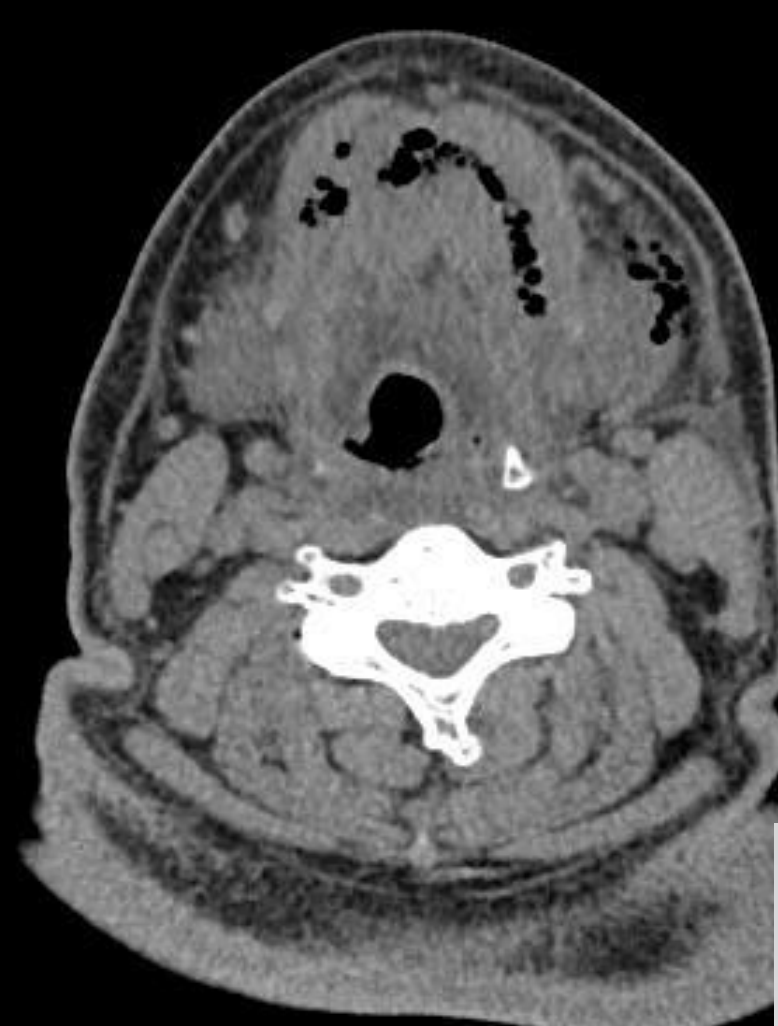
Pre-op Neck CT without C.E  
; because of kidney function

Through Neck CT without C.E and MRI, suspicious abscess lesion was seen on cervical area below submandibular area and Lt. parapharyngeal area. Under general anesthesia, incision and drainage was done on Lt. parapharyngeal area and cervical area.

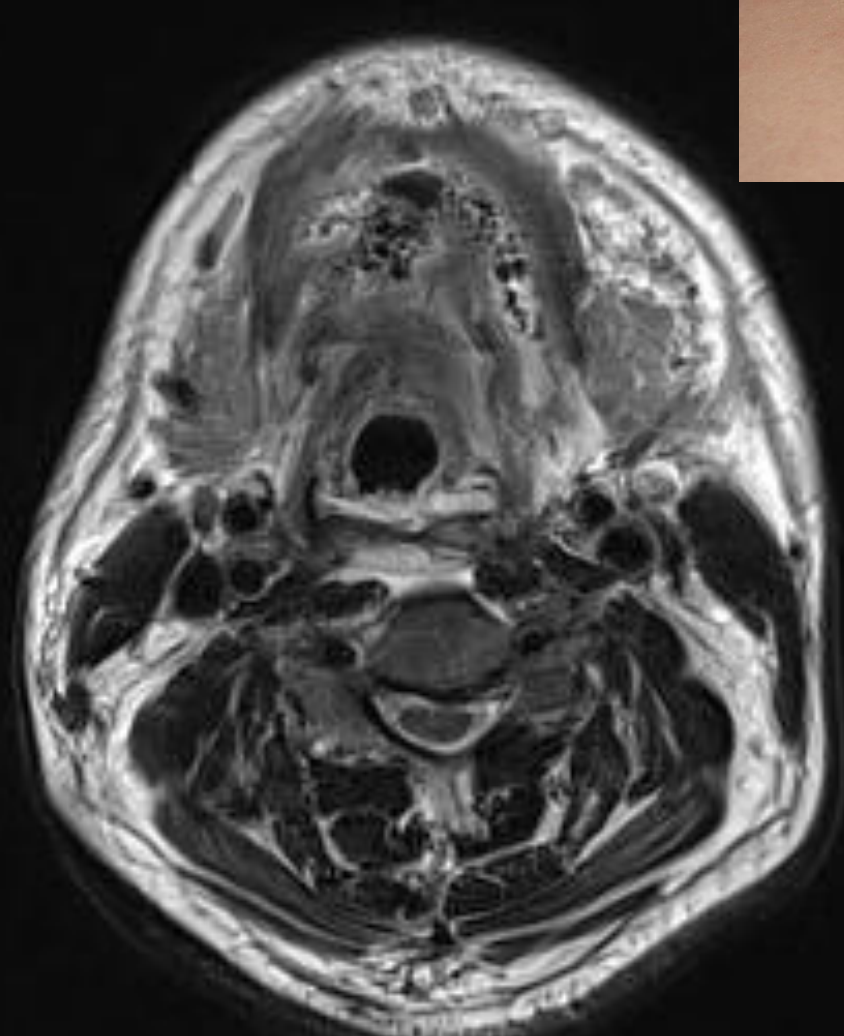
Pre-op MRI  
; because of kidney function

Abscess cavity formation

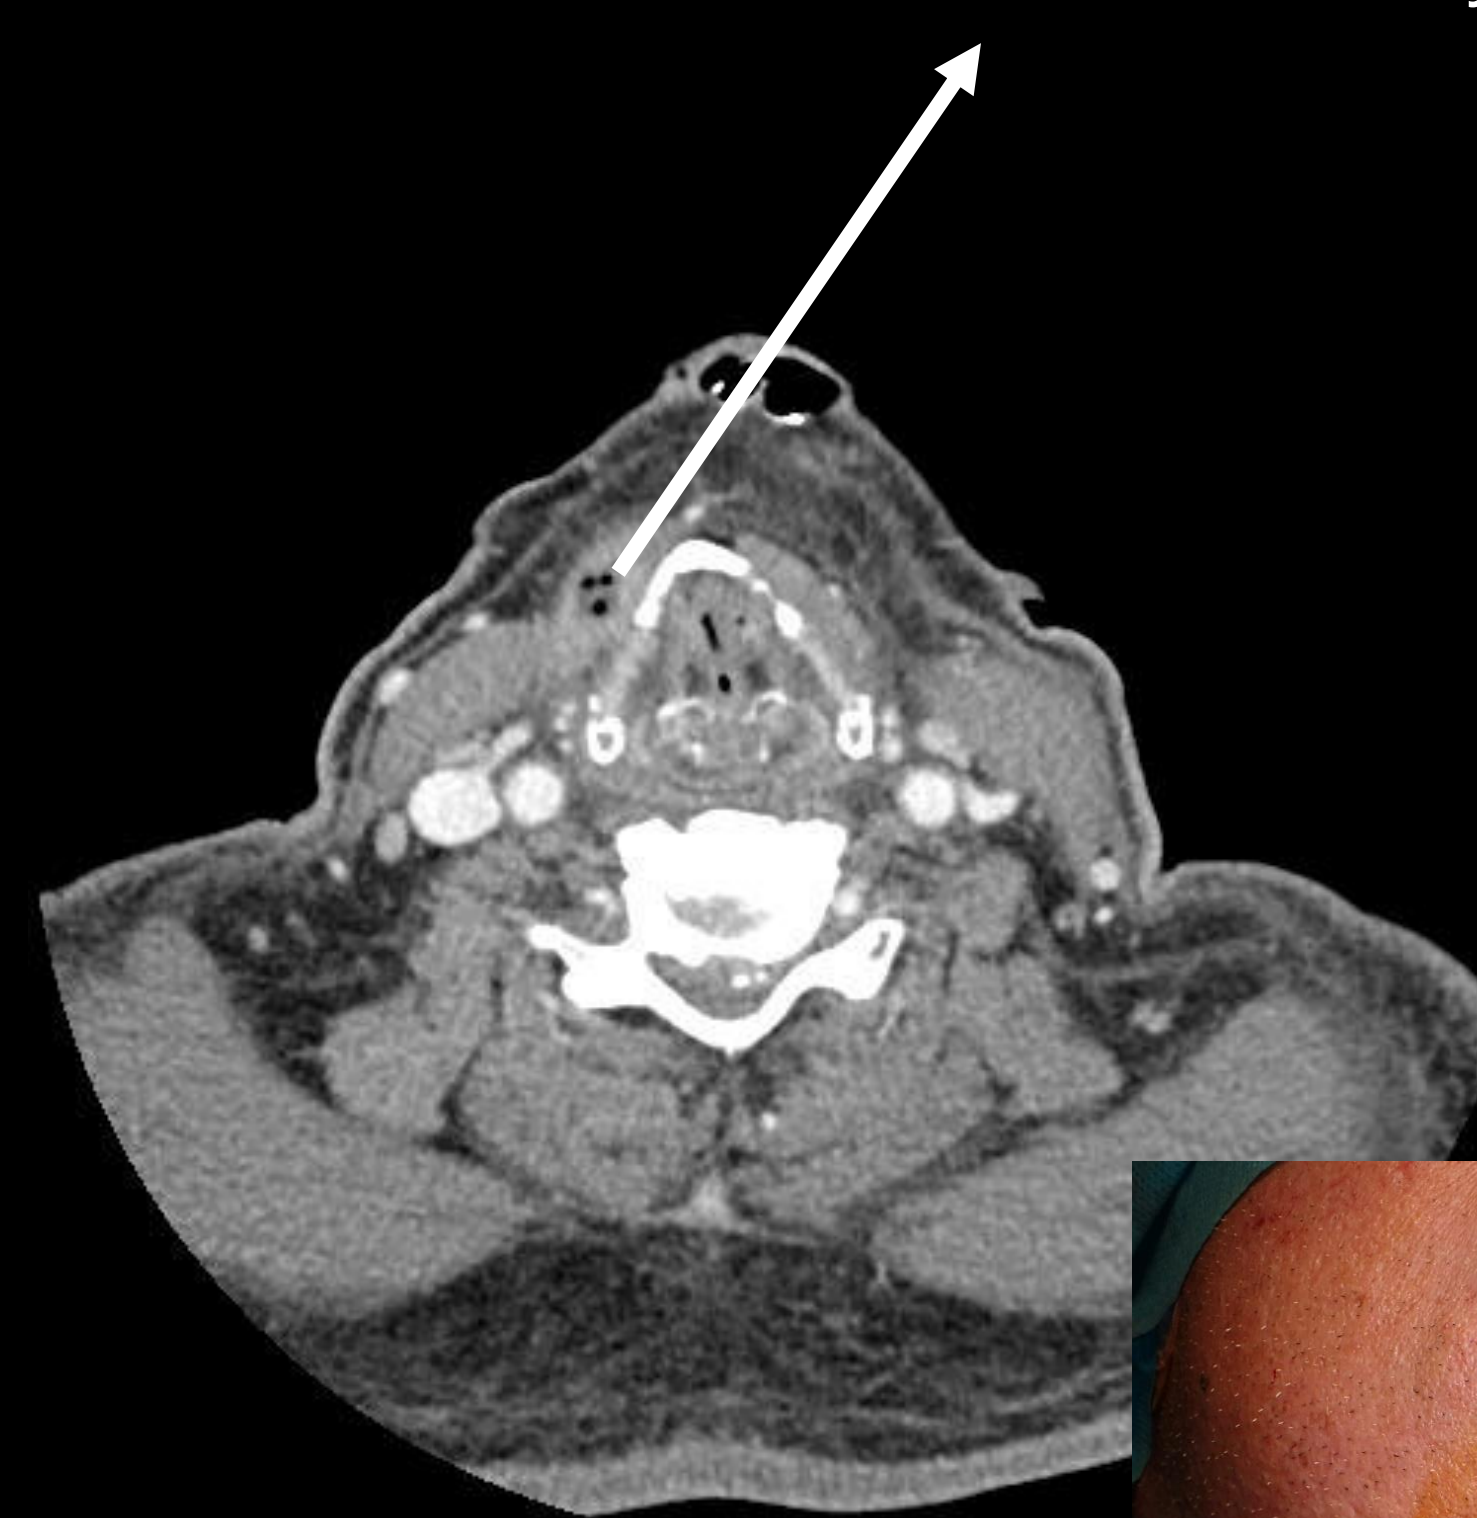
Post-op(1<sup>st</sup> I&D)  
Neck CT with C.E

After taking Neck CT with C.E, we extended the incision line, removed necrotic tissue and took secondary incision and drainage on Lt. parapharyngeal area and visceral space under general anesthesia.

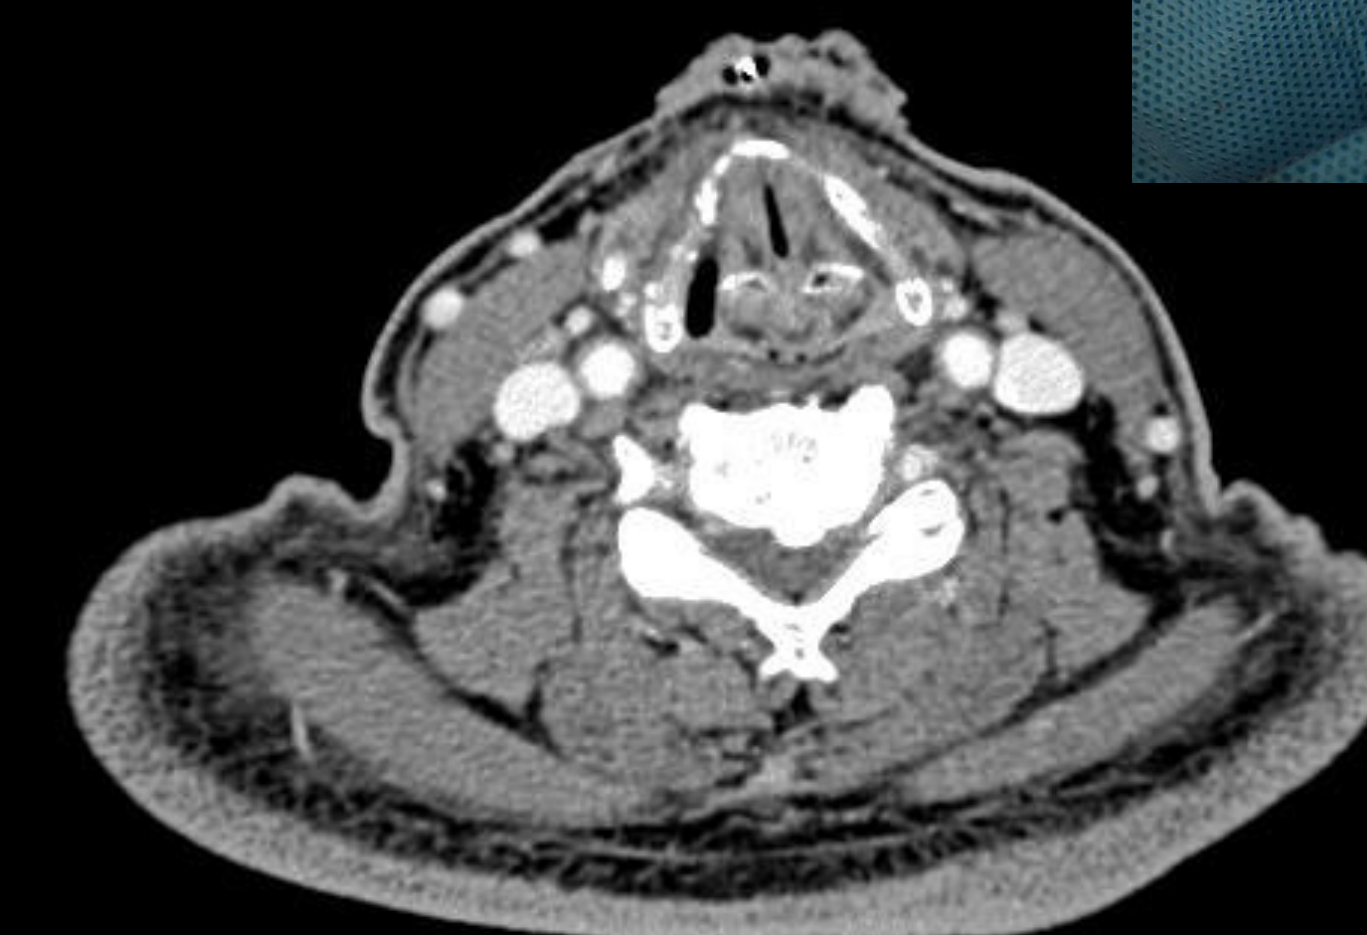
Post-op(2<sup>nd</sup> I&D) Neck CT with C.E  
: abscess cavity disappeared
